# Maryland Historical Trust State Historic Sites Inventory Form

Survey No. F-6-40

historic Log House north of Creagerstown

# LOG HOUSE

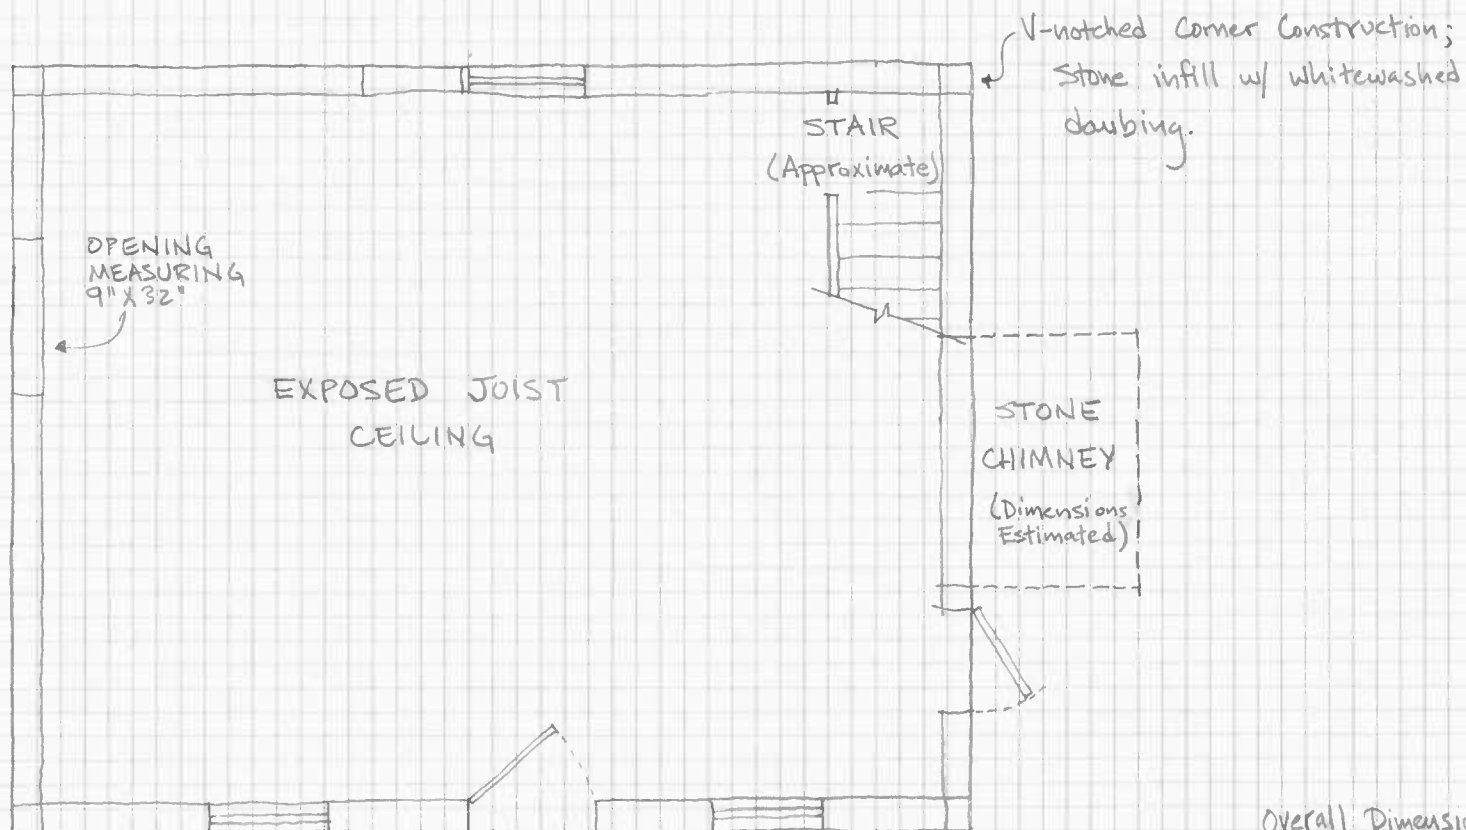
Measured Sketch Plan

The building is a true story-and-one half log structure measuring 16 feet wide and twenty feet long. It is oriented to face south, with a pitched gable roof on an east-west axis. There are three openings in the principal facade; an exterior stone chimney on the east gable wall has collapsed. The logs are hewn on the interior and exterior face but are left unhewn on the top and bottom faces. They average  $7\frac{1}{2}$  -  $8\frac{1}{2}$ " deep, 9 - 12" high, and are V-notched with stone infill. The daubing was originally whitewashed, but the exterior walls were later covered with narrow weatherboard siding nailed to vertical spacer strips with machine-made nails.

The interior of the building was not accessible but a limited view of the building was possible through various openings. The interior consists of a single room on the first floor and a floored loft above. A steep enclosed stair is located in the northeast corner of the building and rises against the east gable wall. This stair is enclosed with beaded boards. The first floor room has an exposed hewn joist ceiling. The loft is unfinished other than the flooring. The moderately pitched roof is of common rafter construction with rough wind-braces let into the tops of the gable end rafter pairs. The eaves are not fully boxed in and the early roofing has been covered with corrugated metal.

Overall Dimensions:  
16'-1" X 20'-1"
